National Dam Inspection Program
Lake Nessmuk Dam (NDI ID PA-00032,
DER ID 59-66, SCS ID PA-601)
SUSQUEHANNA RIVER BASIN

PENNSYLVANIA Phase I Inspection
Report

NDI ID No. PA-00032
DER ID No. 59-66
SCS ID No. PA-601

NATIONAL DAM INSPECTION PROGRAM

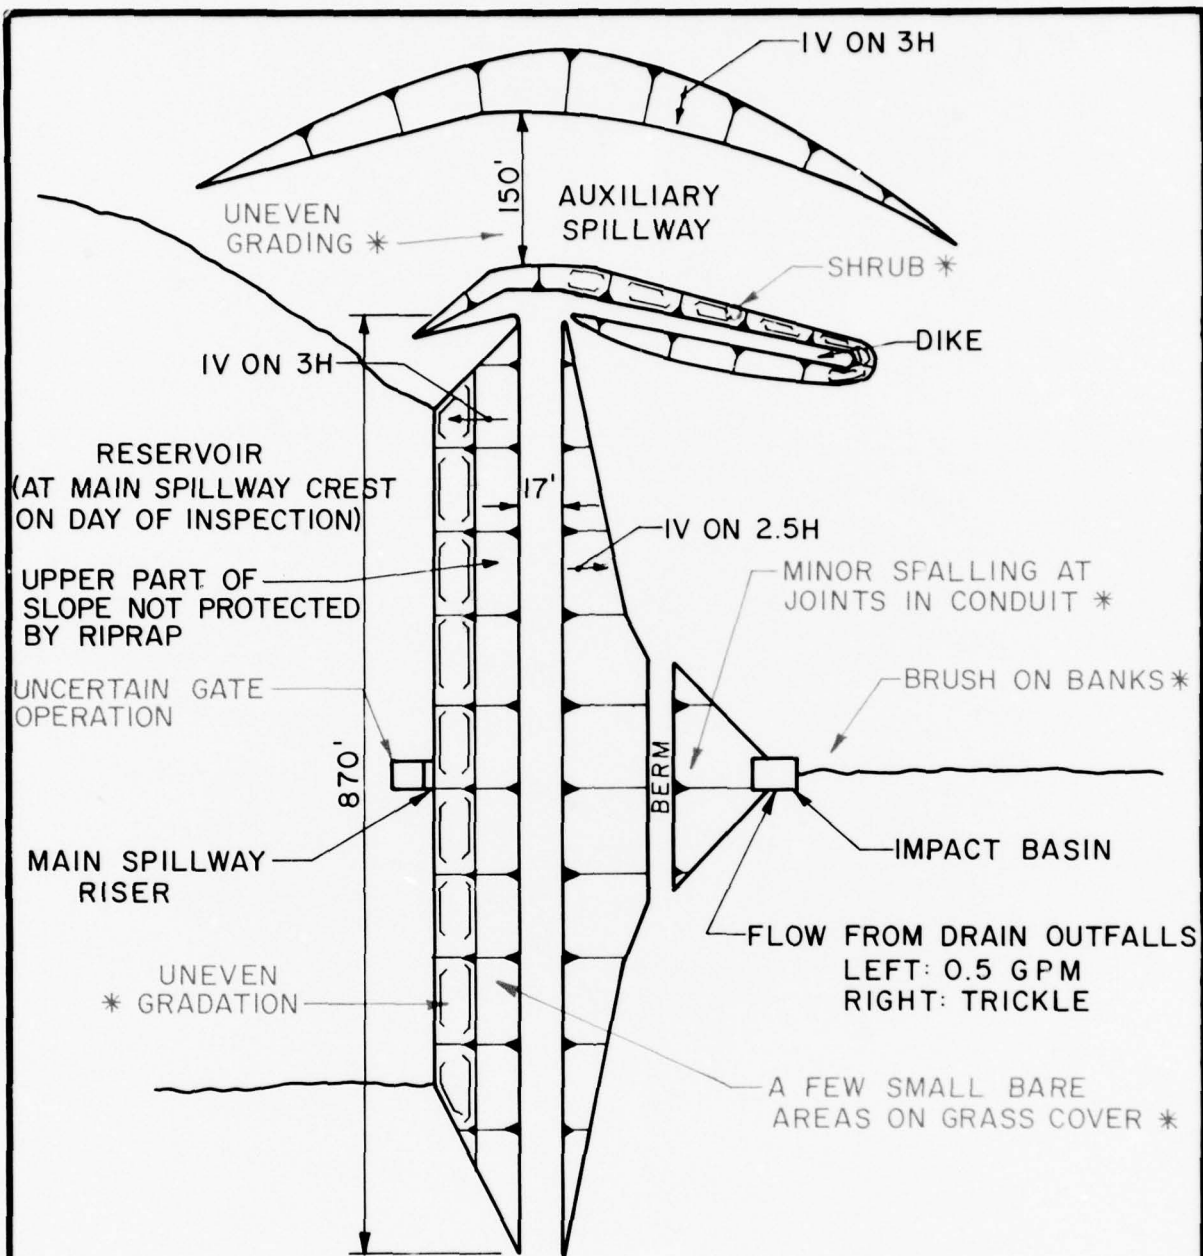
a. General. The overall appearance of the dam is good with a few deficiencies as noted herein. The locations of deficiencies are shown in Appendix B on Plate B-1. Survey data acquired during this inspection are presented in Appendix B. On the day of the inspection, the pool was at spillway crest.

NOTE: ITEMS MARKED * ARE VERY MINOR AND ARE NOT CONSIDERED DEFICIENCIES.

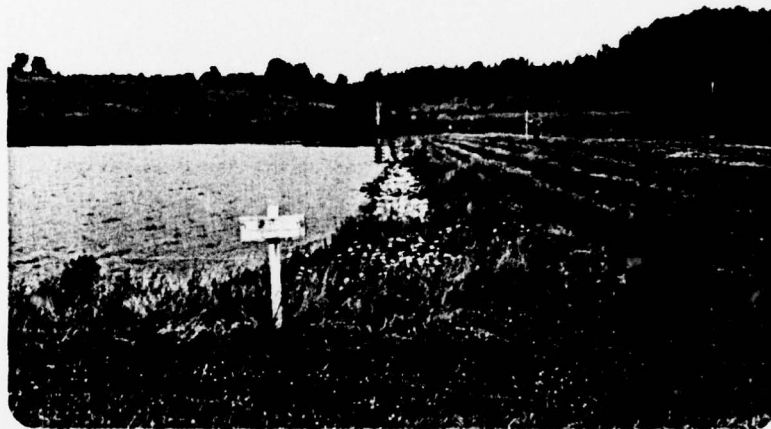
b. Embankment. The embankment is in good condition. The downstream slope is covered with thick 2 to 3-foot high crownvetch. The upstream slope is protected by riprap to about 2.8 feet above the main spillway crest. The remainder of the embankment is covered with grass. A few small areas are almost bare. They are probably the result of being mowed too closely. The gradation of the riprap is somewhat uneven. The survey performed for this inspection revealed that the top of the embankment is above its design elevation and that the lines and grades are essentially in accordance with the design drawings. No seepage was observed on or downstream from the embankment.

A. Upstream Slope

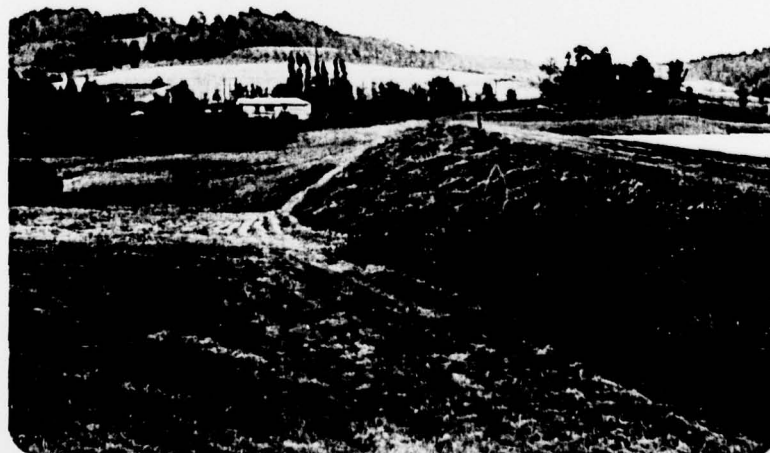
B. Downstream Slope

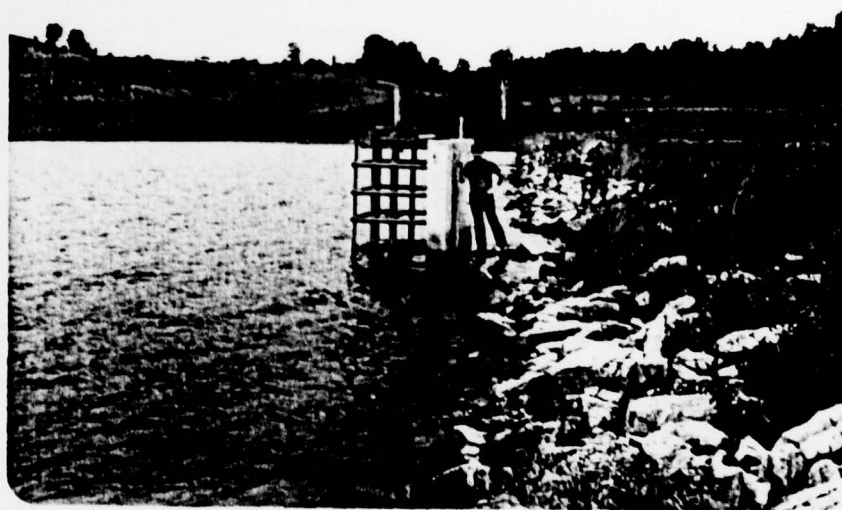
c. Appurtenant Structures. The main spillway riser is in good condition with no observed deficiencies. The main spillway conduit is in good condition. The junction of the riser and the conduit is in good condition. At the conduit joints, each edge facing upstream has minor spalling. As shown on Plate 6, Joints J-10 and J-11 are separated about $3/4$ to 1 inch. Joint J-4 is separated about $1-1/4$ inches. At the junction of the conduit and the impact basin, the caulking in the joint is slightly deteriorated. The impact basin is in good condition with no observed deficiencies. There is a minor amount of brush on the stream banks downstream of the impact basin. The outfall of the foundation drain at the left side of the impact basin was discharging at a rate of 0.5 gpm. The right outfall was trickling.

C. Main Spillway

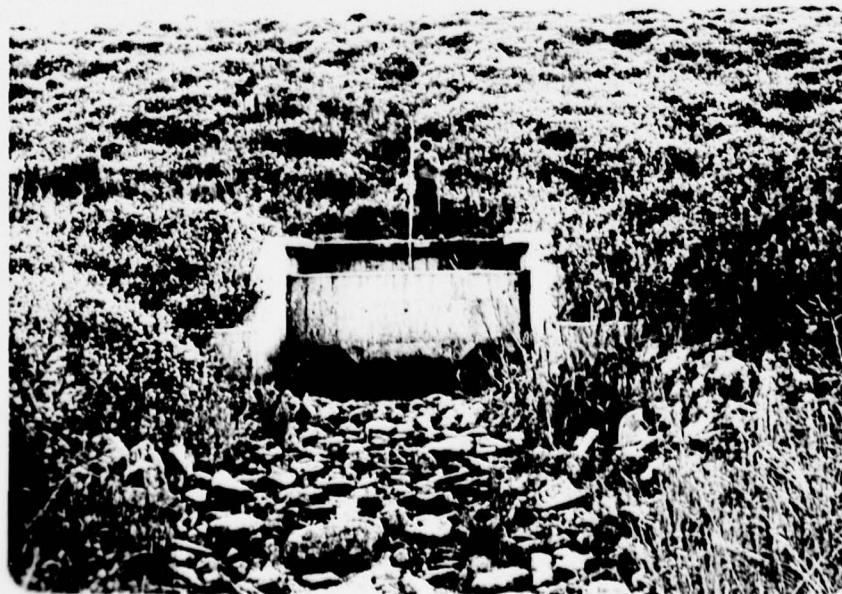
D. Impact Basin
